**The Marine Invasive Non-Native Species *Didemnum vexillum*:
Survey of intertidal and shallow sub-tidal artificial infrastructure in
Loch Creran**

Scottish Marine and Freshwater Science Report Vol 9 No 11

Published by Marine Scotland Science

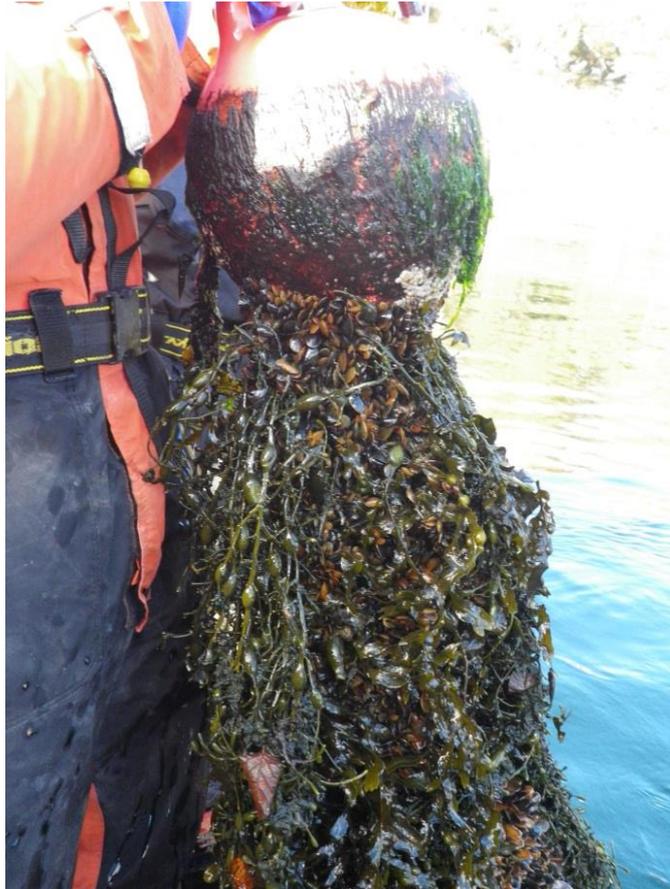
Figure 4: Typical fouling of algae and mussels on mooring

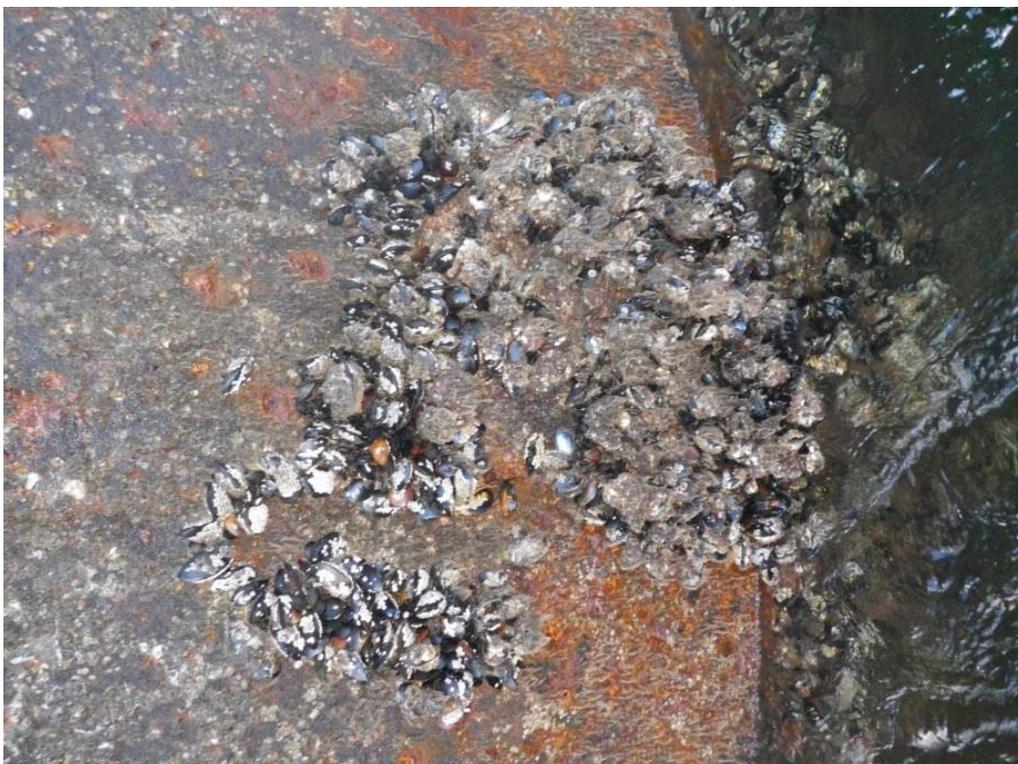
Figure 5: Fouling of mussels and barnacles on central stanchion of bridge.

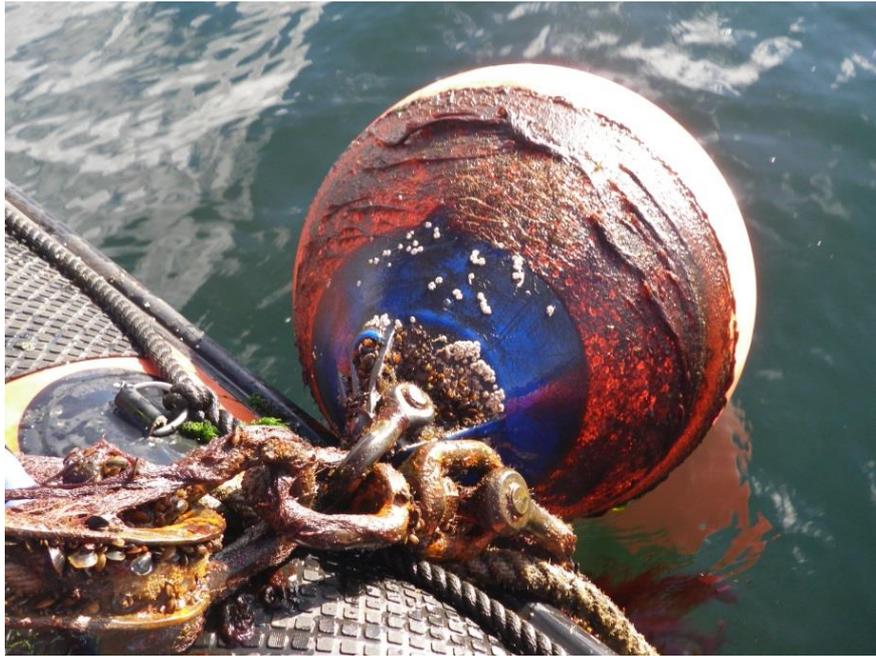
Figure 6: Light fouling of barnacles and mussels on mooring, with mussels visible on the mooring chain.

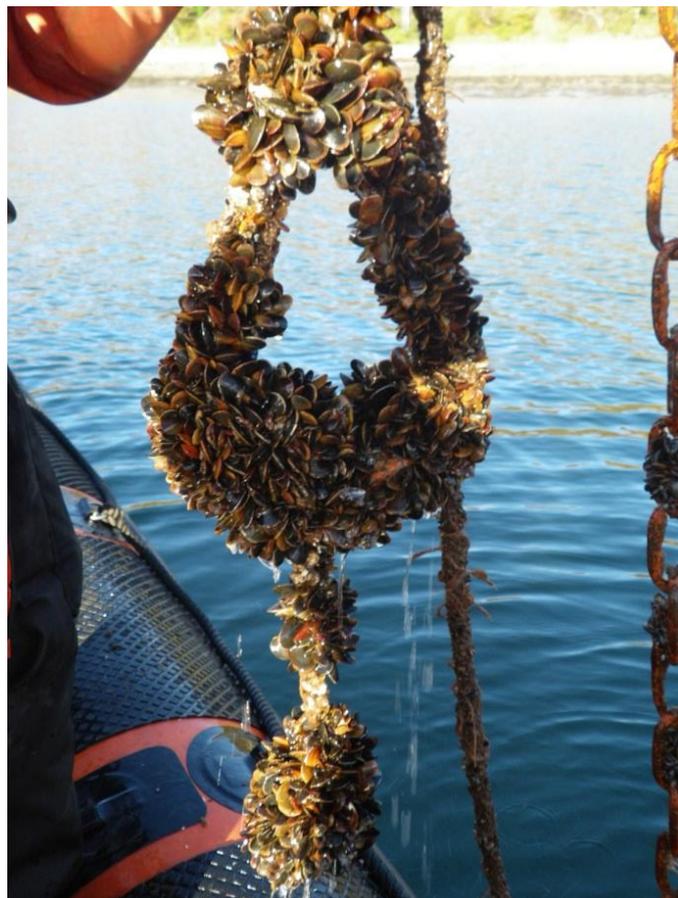
Figure 7: Heavy fouling of mussels on mooring rope.

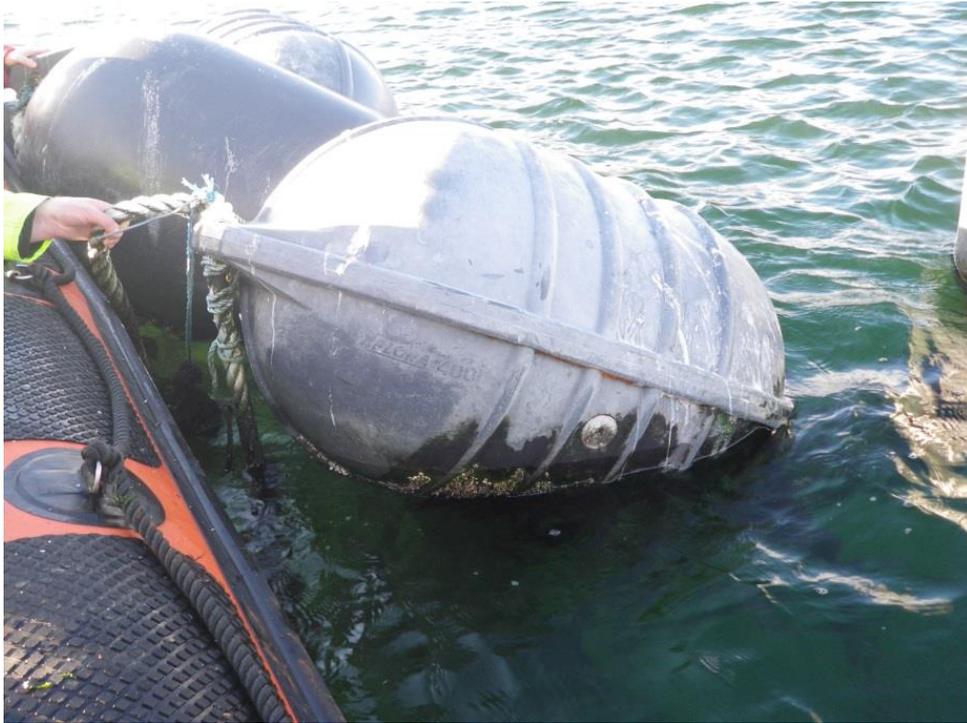
Figure 8: Some fouling of barnacles on disused mussel farm moorings.

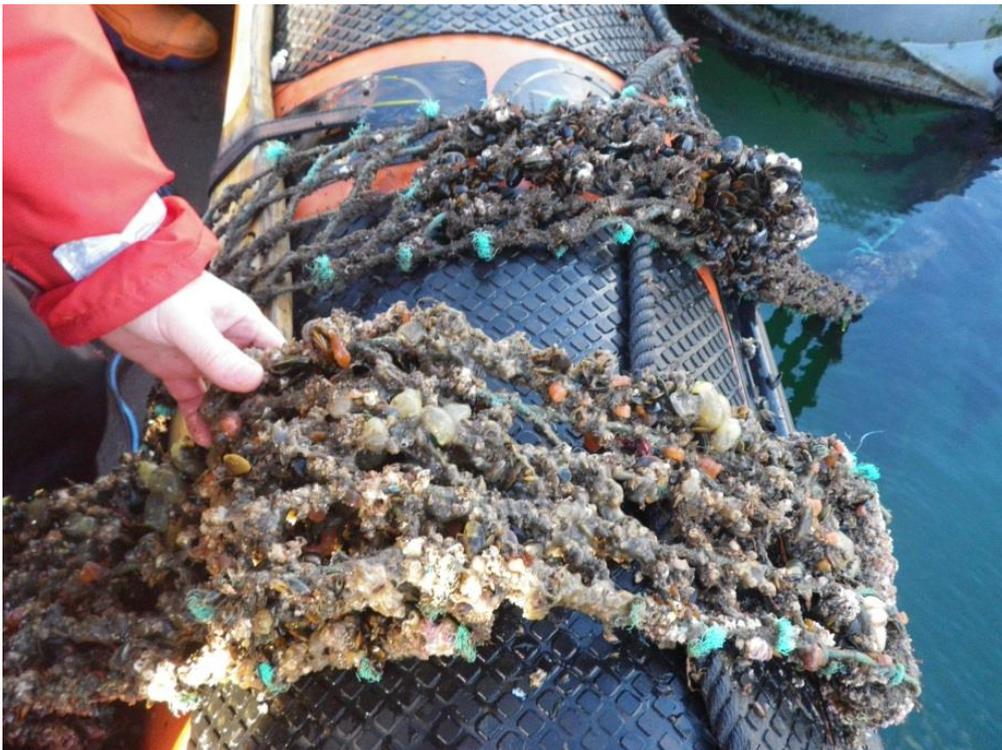
Figure 9: Heavy general fouling assemblage on disused mussel farm netting.

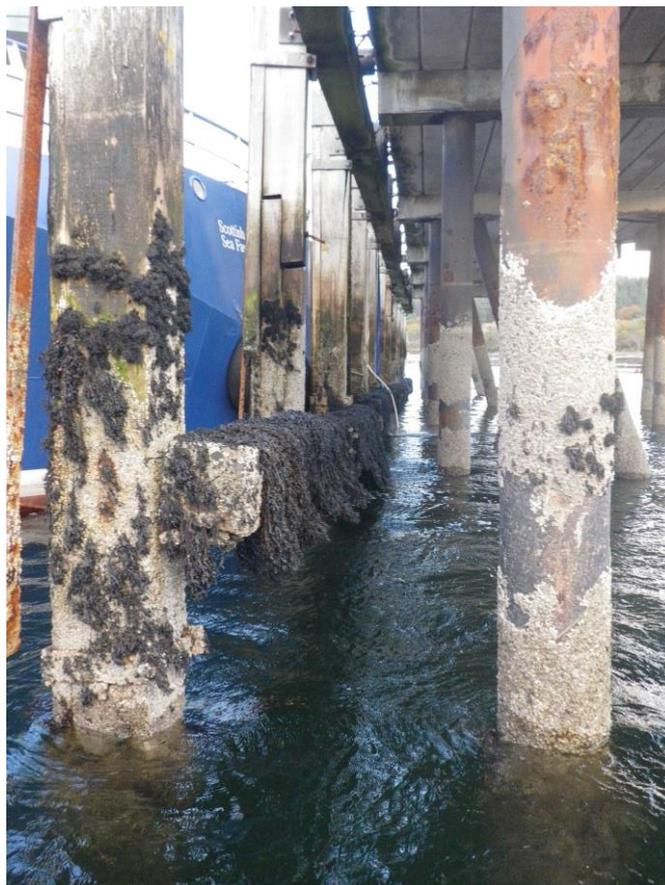
Figure 11: Fouling of pier at Barcaldine, Marine Resource Centre with algae, mussels and barnacles.

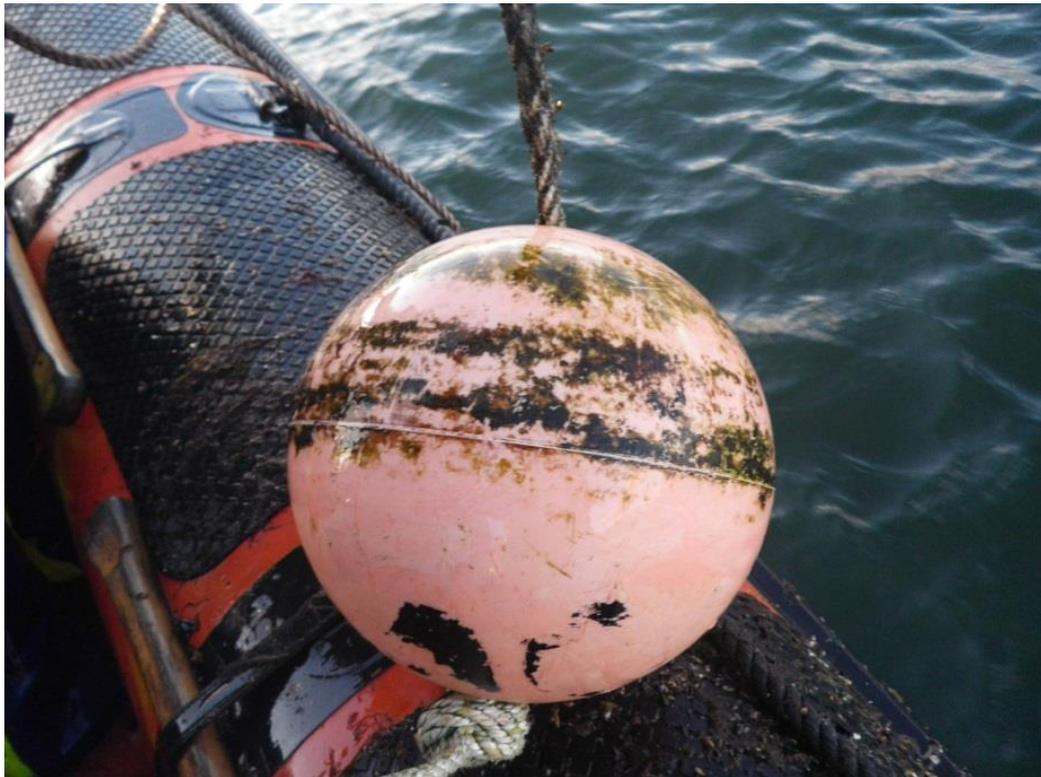
Figure 13: Light algal biofilm on mooring.

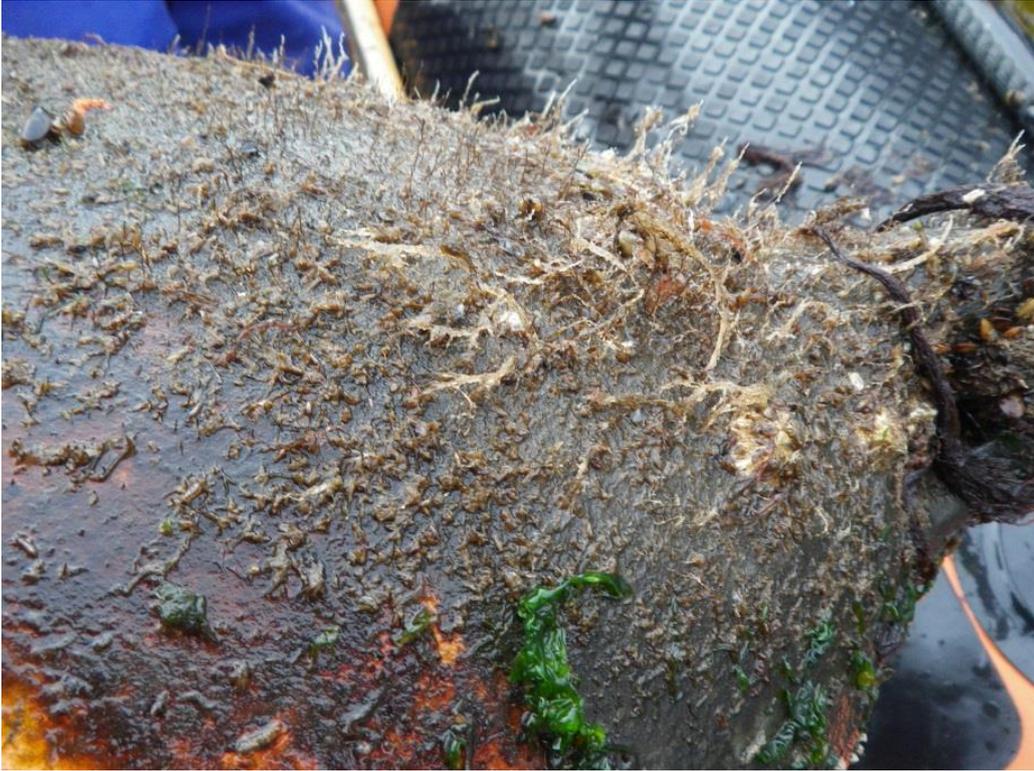
Figure 14: Hydroids and some algae present on a mooring.

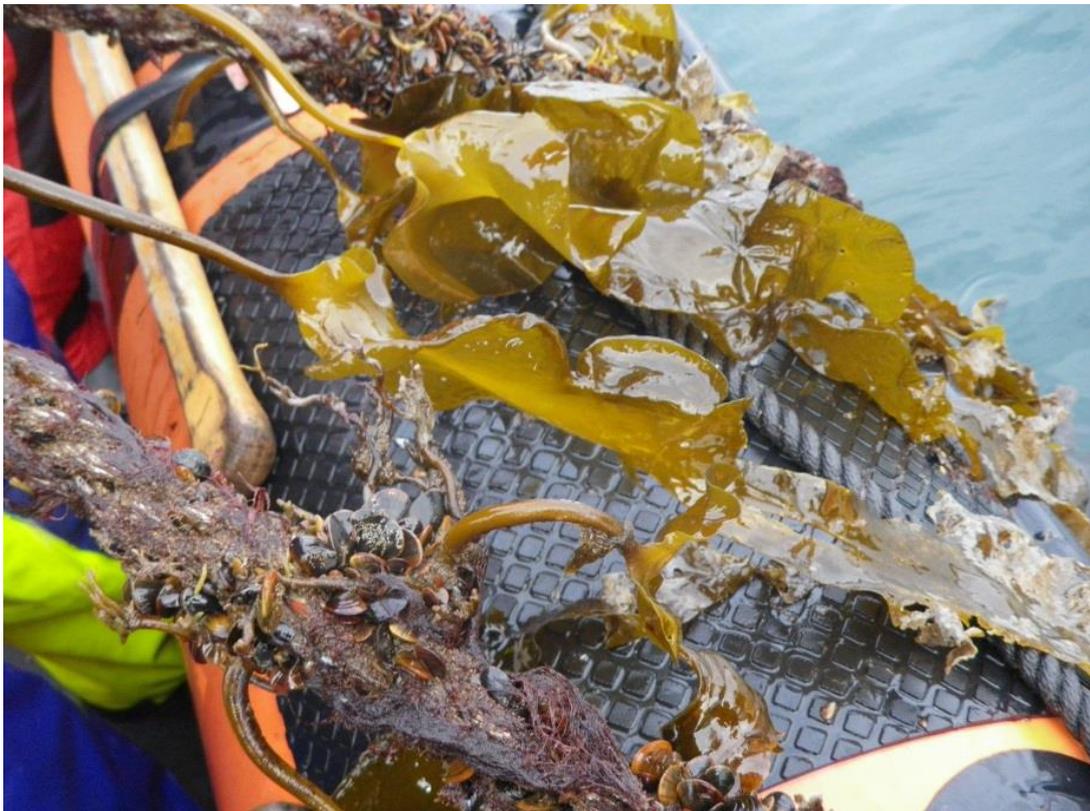
Figure 15: Fouling of algae and mussels on mooring ropes.

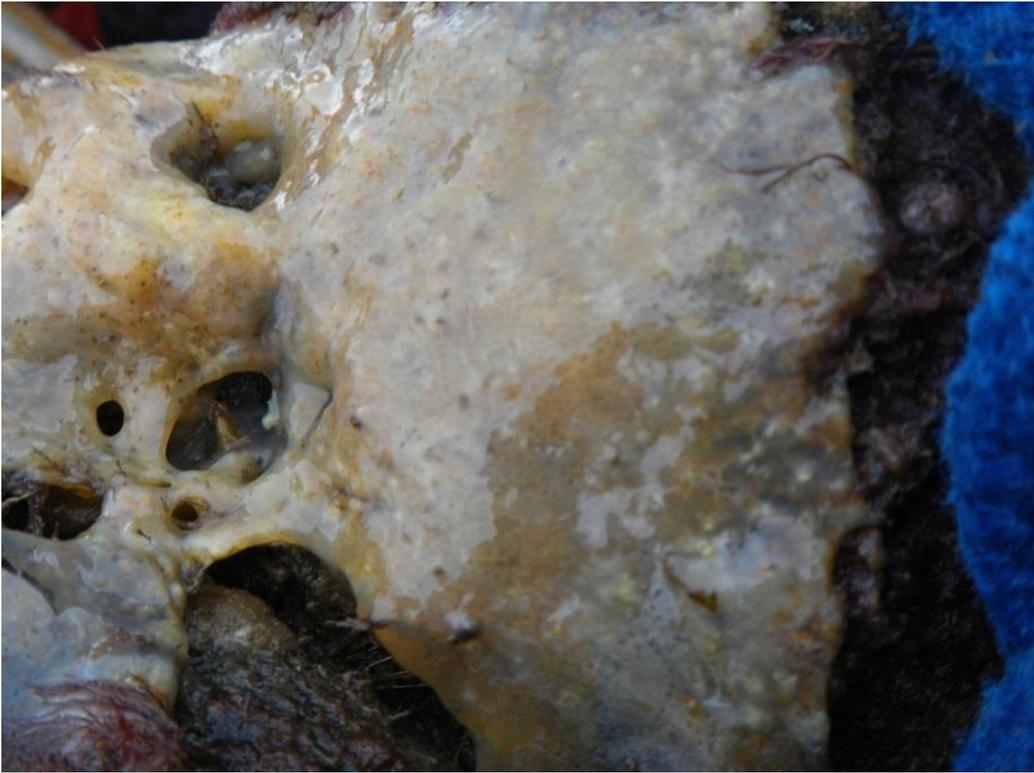
No Dvex-looking material was observed on any surveyed structure. General fouling communities consisting of algae, mussels, barnacles, amphipods, bryozoans and solitary and colonial sea squirts were found on moorings, pontoons, piers, rafts and the bridge (Figures 3 – 20). Vessel hulls were in good order, some with the beginnings of an algal biofilm and barnacles. Screen shots from GoPro footage show typical fouling on each of the surveyed structure types (Figures 21 – 29). No colonial sea squirt observed resembled Dvex, however two unidentified samples were collected for molecular identification to confirm that they are not Dvex (M29 (LcDv42) and R1 (LcDv41), Table 2 and Figure 16). Sequencing of the partial COI gene indicated that the unidentified organisms was not Dvex but a *Rophalaea*-like tunicate.

Figure 16: Unidentified colonial tunicate (*Rophalaea*-like) on mooring M29.
