# The Marine Invasive Non-Native Species *Didemnum vexillum*: Survey of intertidal and shallow sub-tidal artificial infrastructure in Loch Creran

Scottish Marine and Freshwater Science Vol 9 No 11

L Brown, M Gubbins, D Donnan and J Dodd

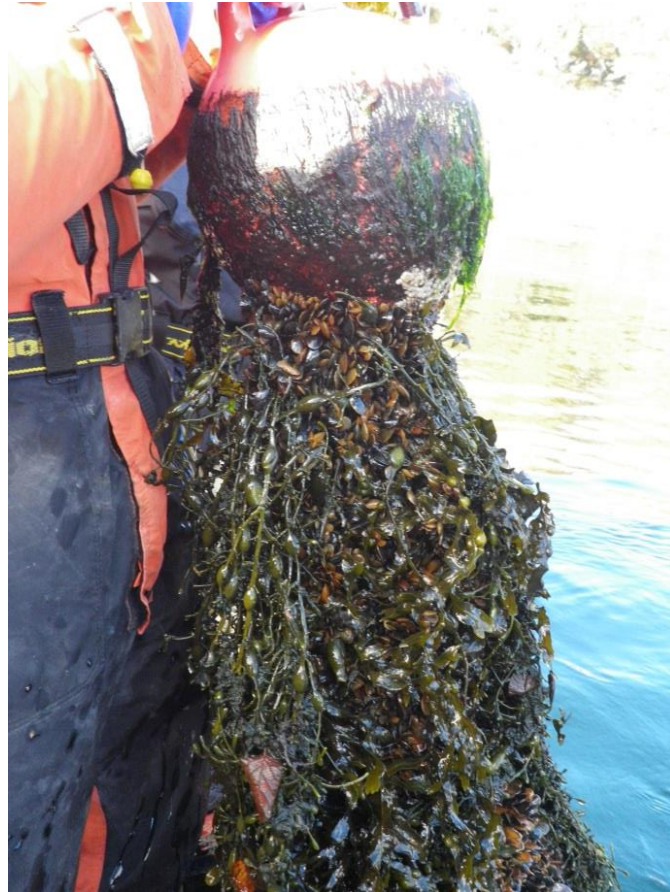
**Figure 4:** Typical fouling of algae and mussels on mooring

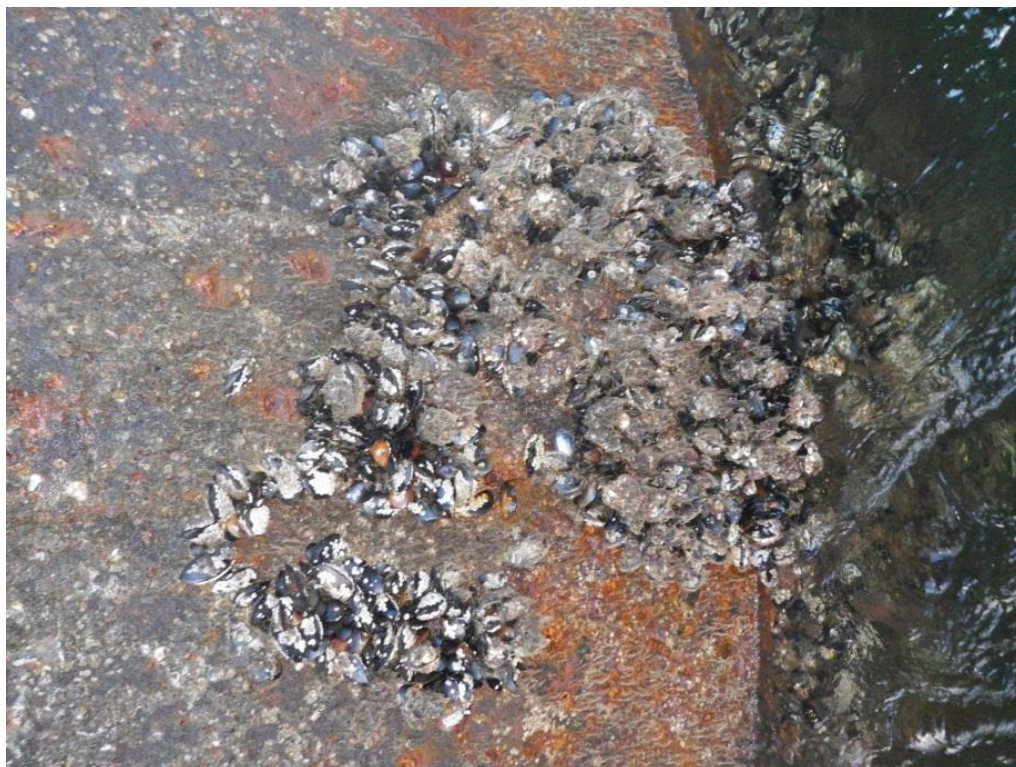
**Figure 5:** Fouling of mussels and barnacles on central stanchion of bridge.

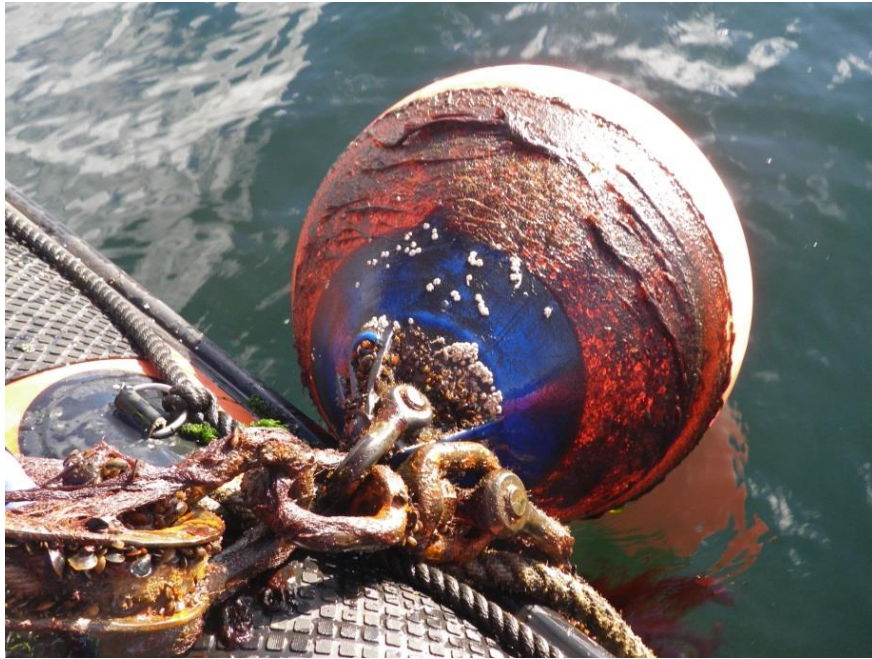
**Figure 6:** Light fouling of barnacles and mussels on mooring, with mussels visible on the mooring chain.

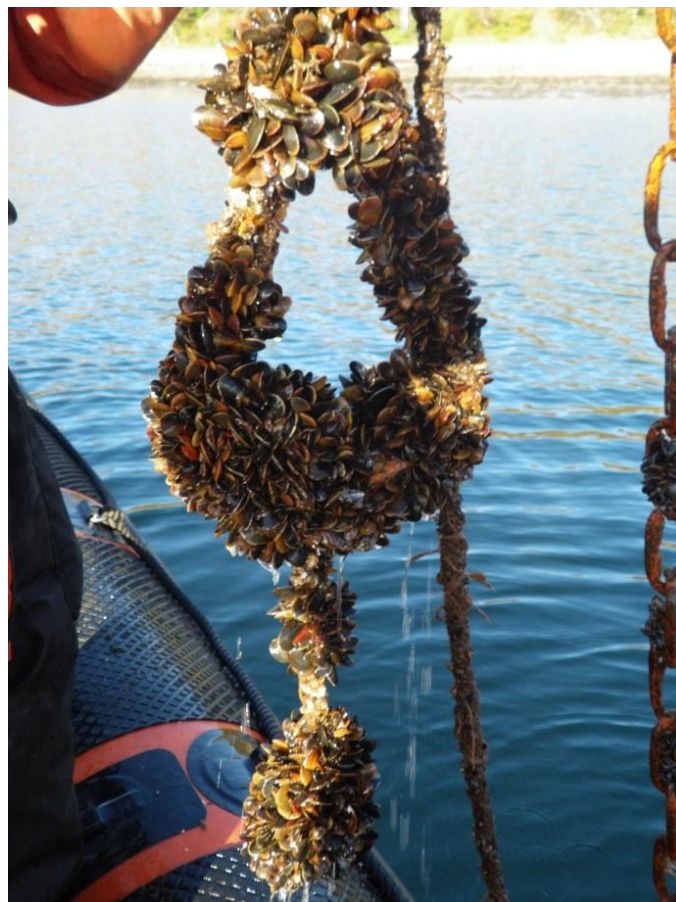
**Figure 7:** Heavy fouling of mussels on mooring rope.

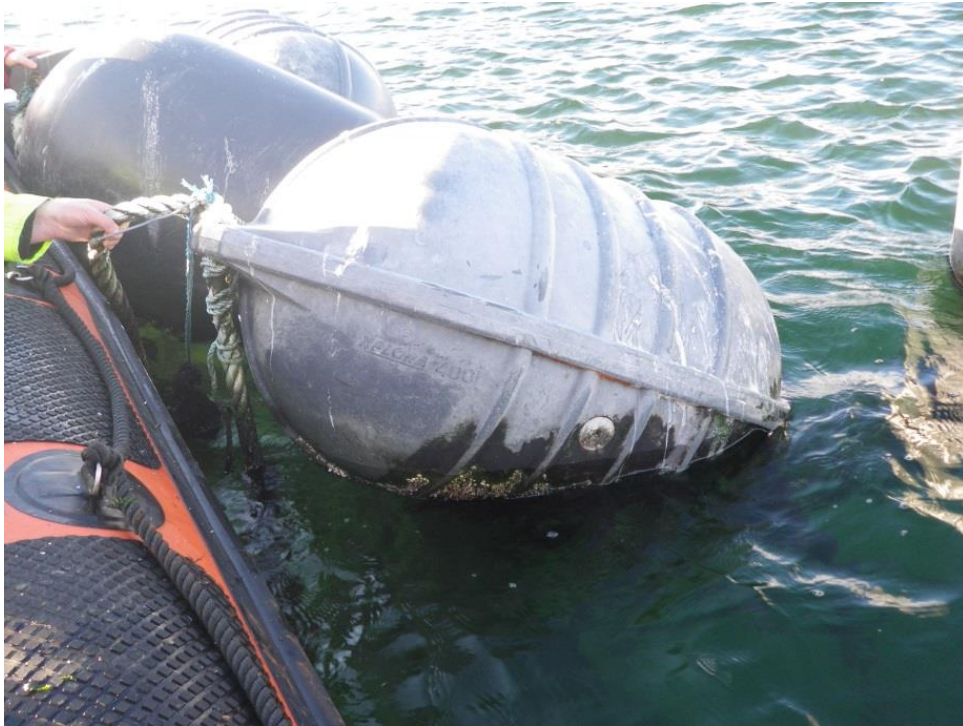
**Figure 8:** Some fouling of barnacles on disused mussel farm moorings.

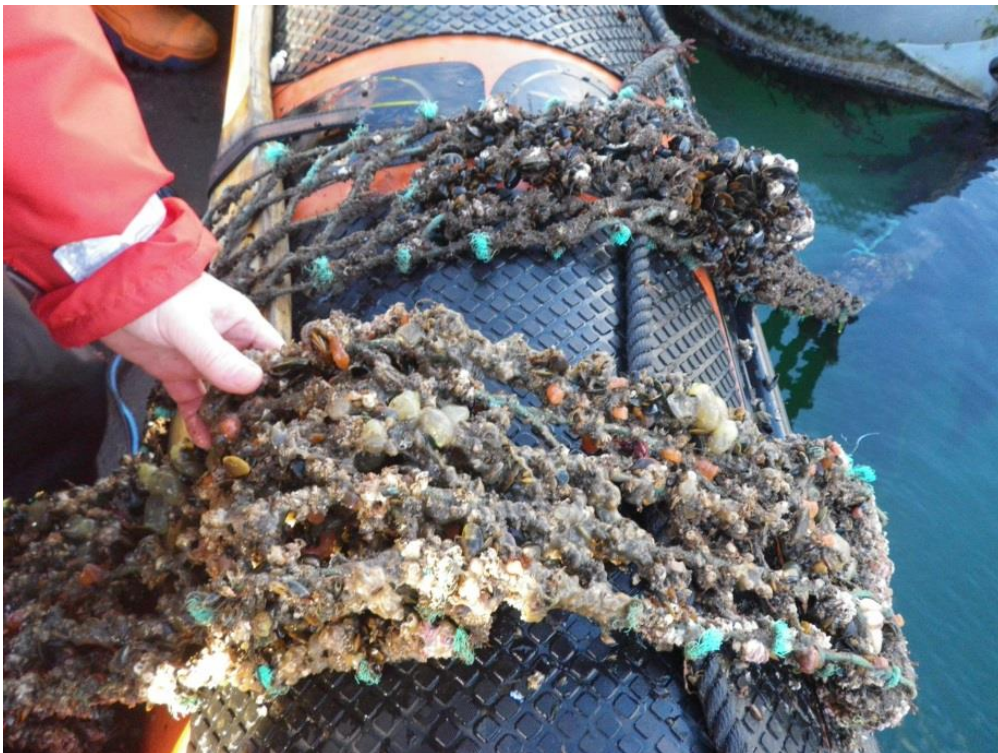
**Figure 9:** Heavy general fouling assemblage on disused mussel farm netting.

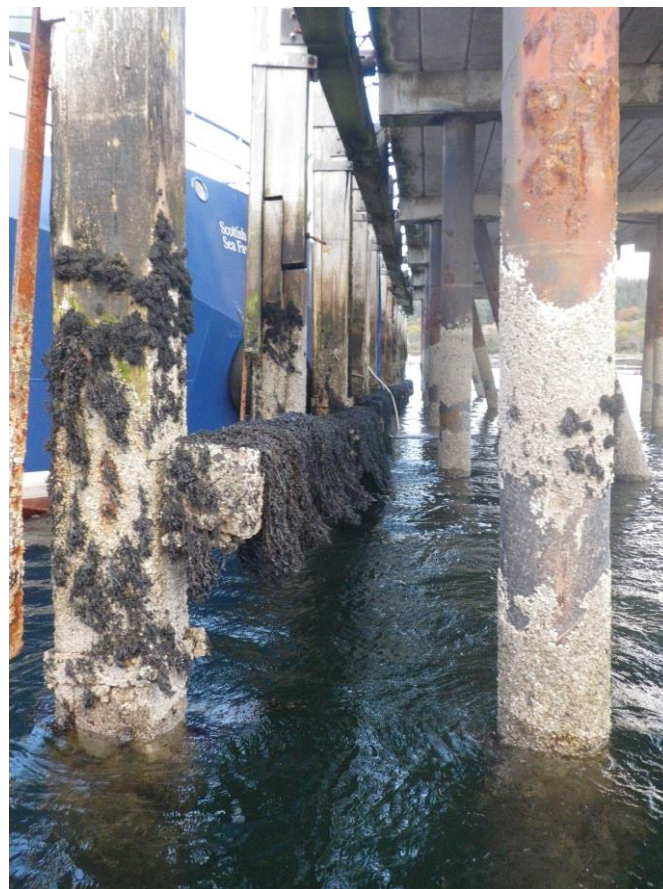
**Figure 11:** Fouling of pier at Barcaldine, Marine Resource Centre with algae, mussels and barnacles.

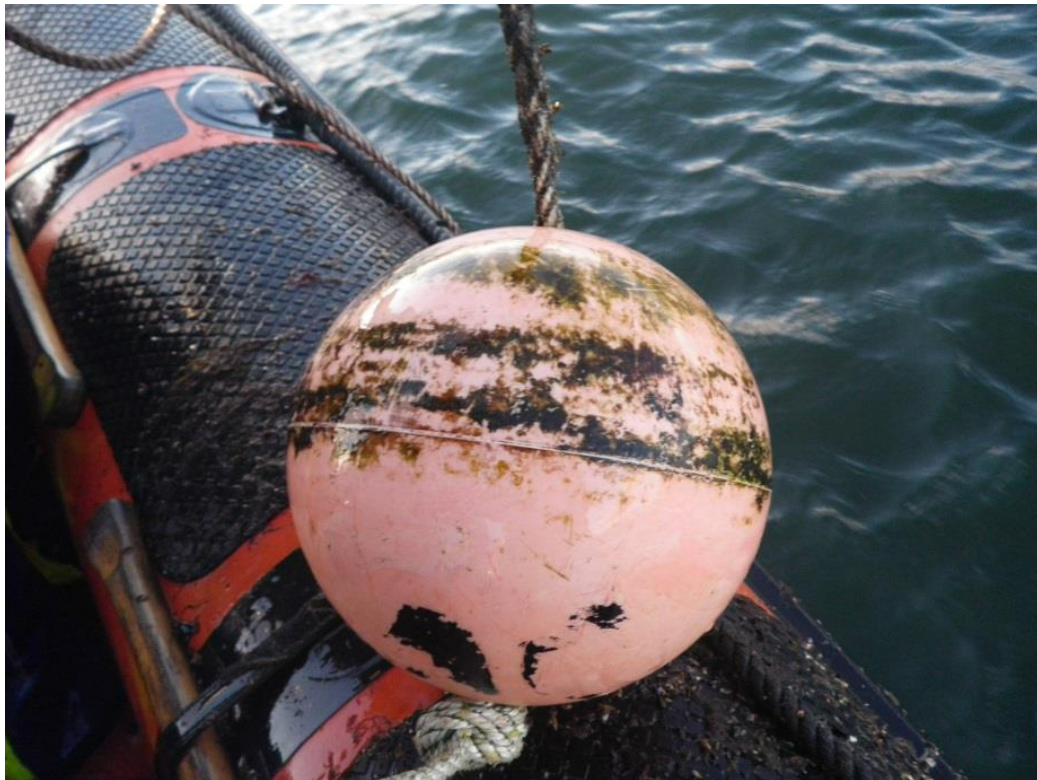
**Figure 13:** Light algal biofilm on mooring.

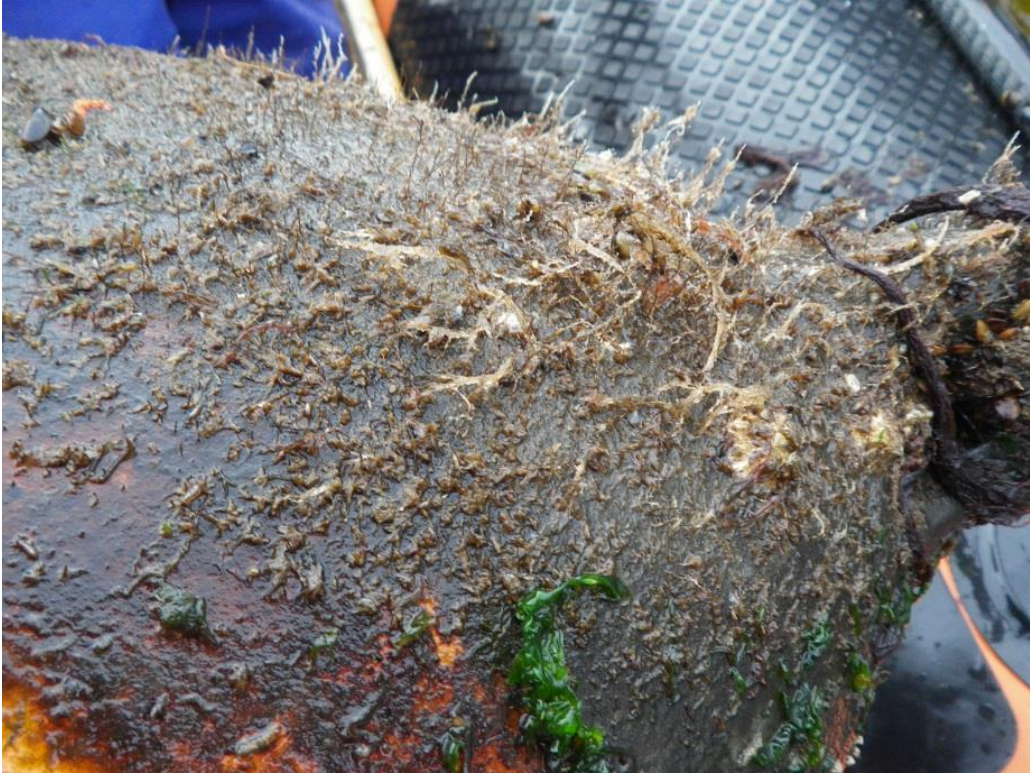
**Figure 14:** Hydroids and some algae present on a mooring.

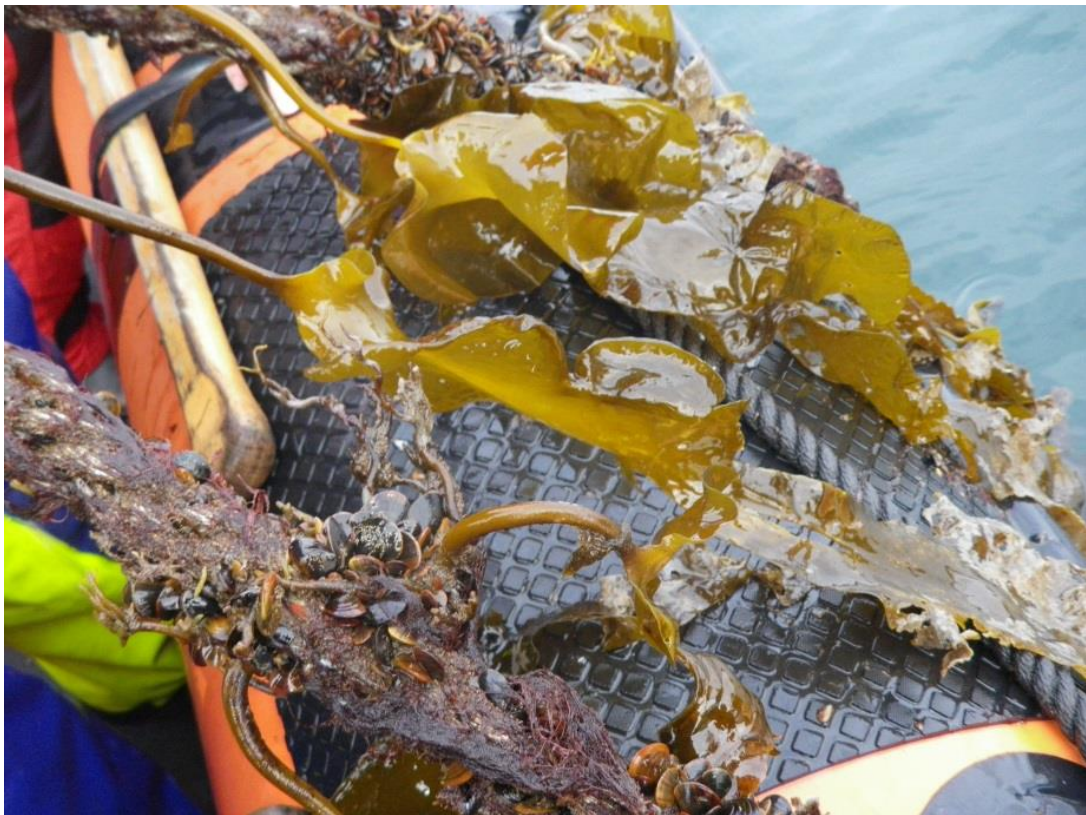
**Figure 15:** Fouling of algae and mussels on mooring ropes.

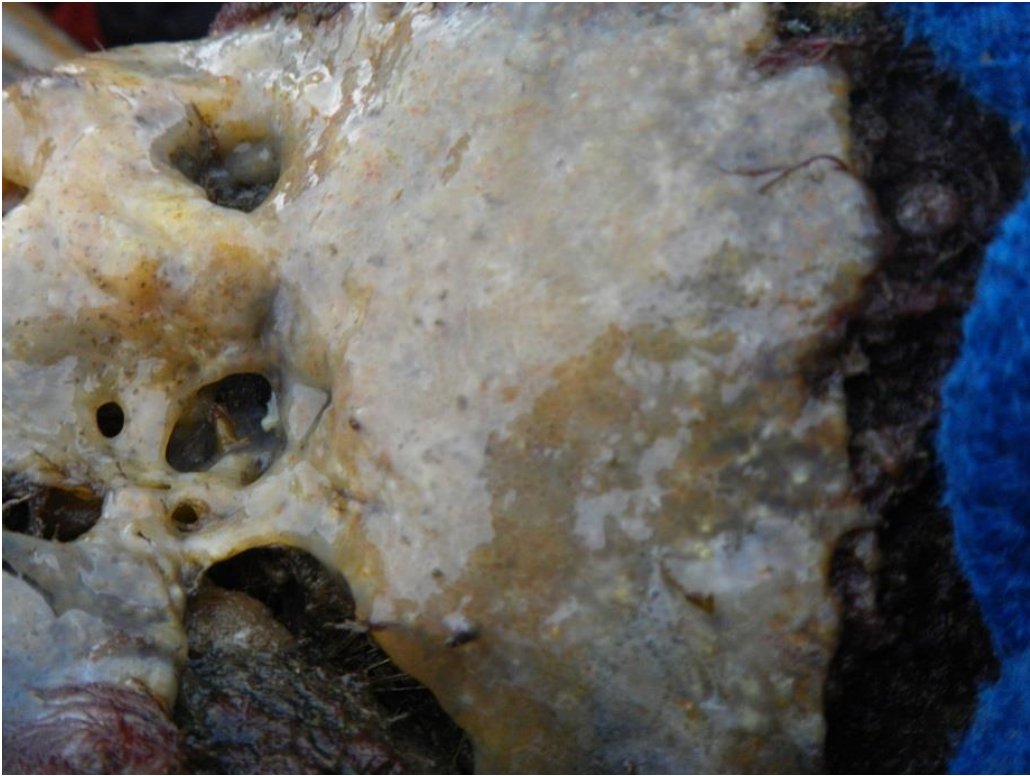
No Dvex-looking material was observed on any surveyed structure. General fouling communities consisting of algae, mussels, barnacles, amphipods, bryozoans and solitary and colonial sea squirts were found on moorings, pontoons, piers, rafts and the bridge (Figures 3 – 20). Vessel hulls were in good order, some with the beginnings of an algal biofilm and barnacles. Screen shots from GoPro footage show typical fouling on each of the surveyed structure types (Figures 21 – 29). No colonial sea squirt observed resembled Dvex, however two unidentified samples were collected for molecular identification to confirm that they are not Dvex (M29 (LcDv42) and R1 (LcDv41), Table 2 and Figure 16). Sequencing of the partial COI gene indicated that the unidentified organisms was not Dvex but a *Rophalaea*-like tunicate.

**Figure 16:** Unidentified colonial tunicate (*Rophalaea*-like) on mooring M29.
