# Final Incident Support Information -Transocean Winner January 2018

Scottish Marine and Freshwater Science Vol 9 No 1

P Hayes

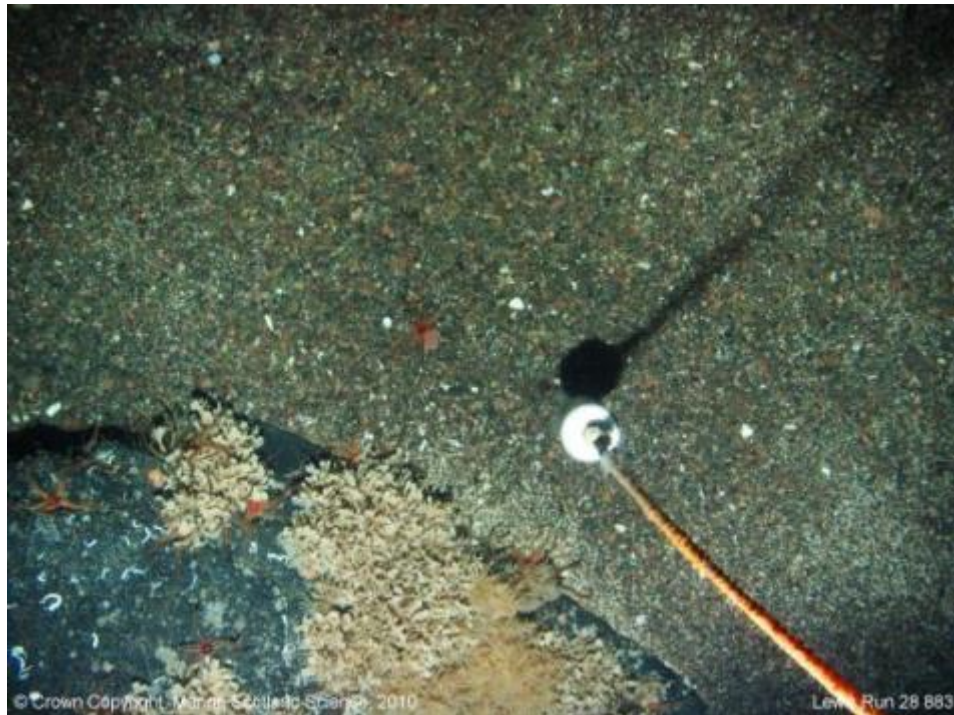
**Figure 7:** Seabed image typical for the area adjacent to the location of the incident.

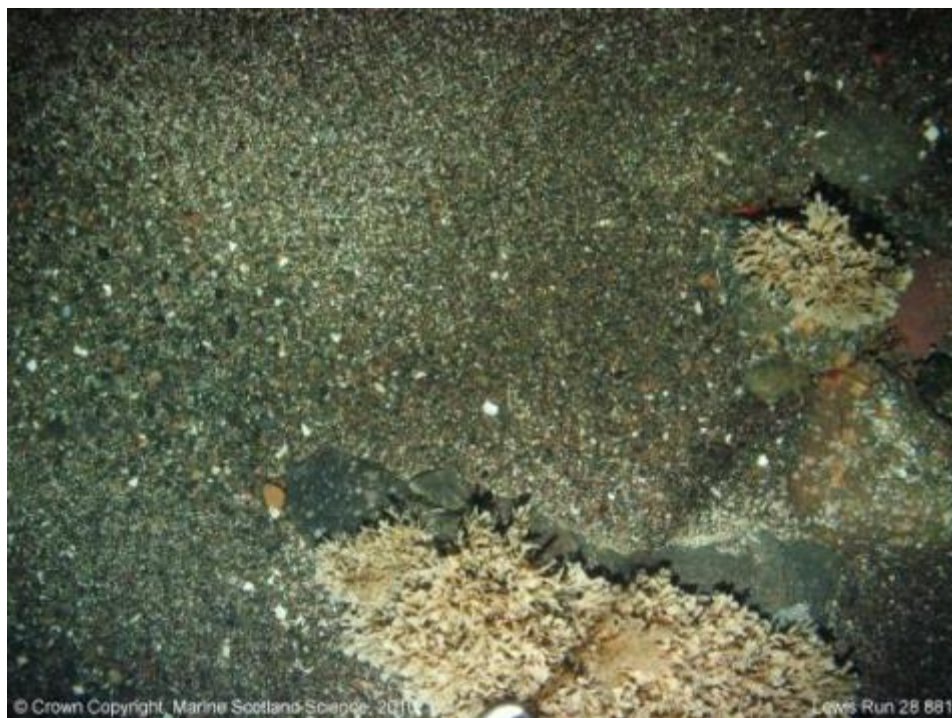
**Figure 10:** Seabed image typical for the area adjacent to the location of the incident.

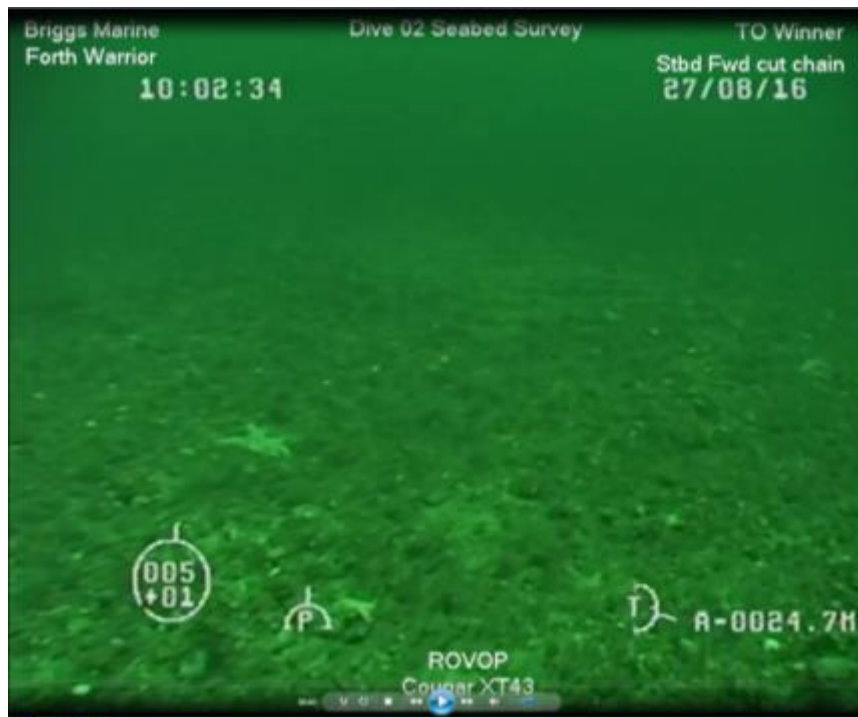
**Figure 11:** Seabed image from the Broad Bay refuge location. Image provided by Oceaneering and Transocean (© Copyright Transocean)

and the interpretation is limited by the detail recorded. Typically the two video tows show a mixture of flat or rippled sand and mixed sediment habitats. The mixed sediment support a more diverse community of starfish and urchins and juvenile fish. Scallops could not be identified because of the detail provided by the video-footage. No evidence of *Nephrops* burrows was observed in the soft sediment. Logs of the seabed video-footage recording fauna and substrate are recorded in Appendix 7. The following photographs (Figures 11-13) were collected as part of the survey work conducted in Broad Bay.

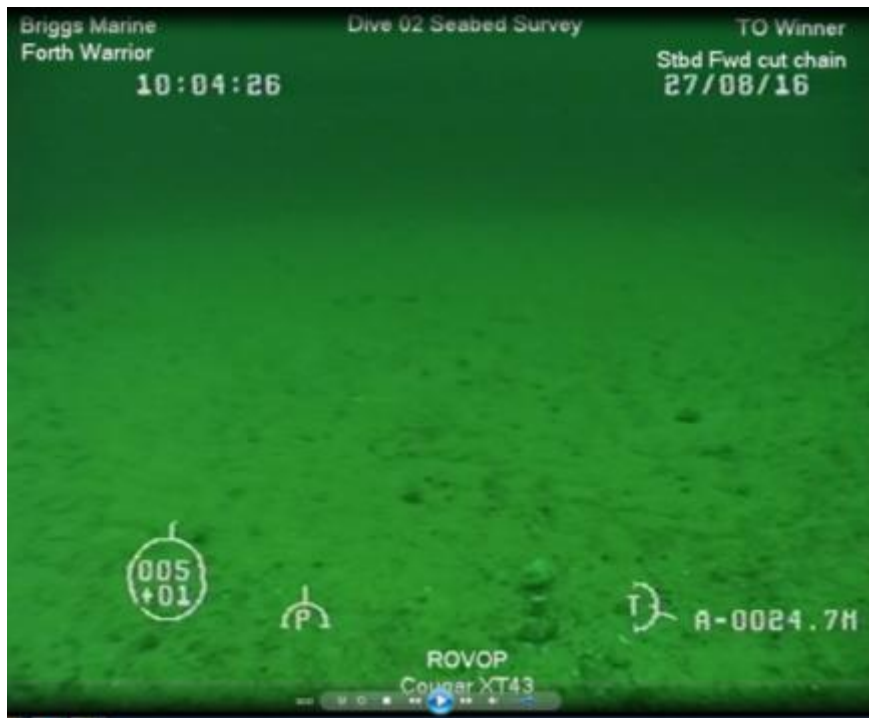
**Figure 12:** Seabed image from the Broad Bay refuge location. Image provided by Oceaneering and Transocean (© Copyright Transocean)

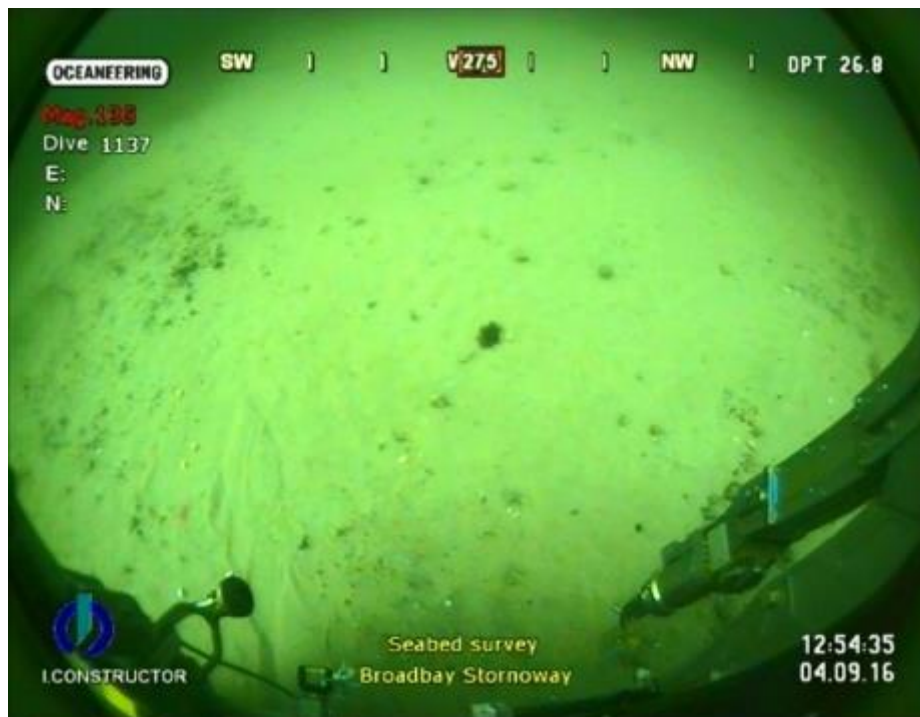
**Figure 13:** Seabed image from the Broad Bay refuge location. Image provided by Oceaneering and Transocean (© Copyright Transocean)

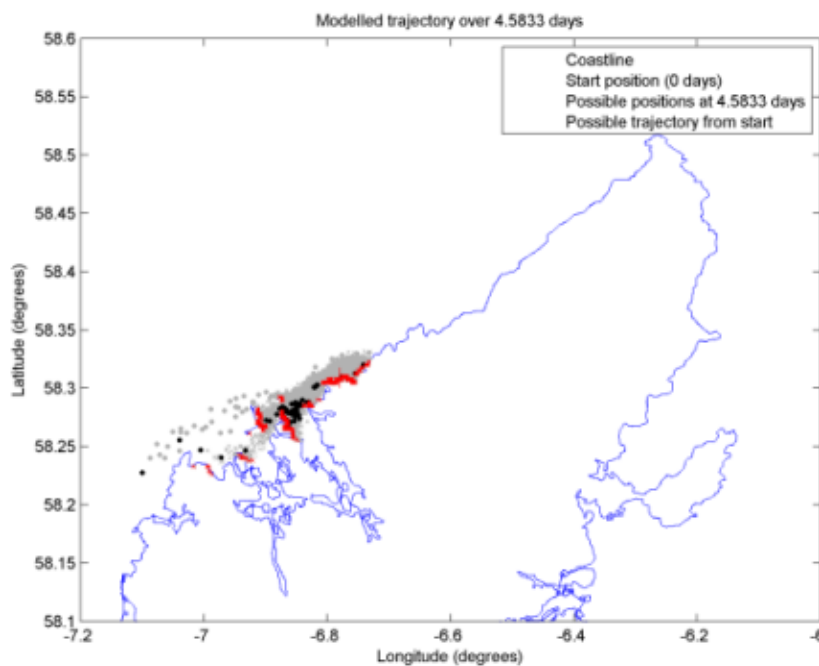
**Figure 17:** Forced oil spill predictions using GNOME modelling tool to determine the conditions resulting in the spill migrating to Loch Roag. Provided by Marine Scotland Science

The model was repeated using the same software, with forecast currents from the UK Met Office's Atlantic Margin Model, and **consistent winds from the NE at 30 knots**. The splots in the water are marked as black and the ones on the beach in red. Particles were released from 10:00 August 8 for 24 hours following them for five

days. The total inventory of diesel (280 m<sup>3</sup>) was released using surface currents. The particles are transported to the SW as far as the mouth of western Loch Roag.

The worst case for Loch Roag would be winds from the NE (transporting particles towards the mouth of Loch Roag) followed by a change in wind direction with winds from the NW which would then push the particles into the loch. The output looks similar for consistent winds at 10 and 20 knots. Figure 17 below shows the worst case modelled output after 4.5 days applying a 30 knot NE wind.
